REPORTNUMBER: 202404-25884

Report

Subject	Report
Inspection date/location	11.04.2024 Dick Automobile e.K., Ernst-Abbe-Str. 2, DE-36179 Bebra
Client	Dick Automobile e.K., Otto-Hahn-Str. 4-6, DE-36179 Bebra
Registration number	HF-JR 294
Vehicle Identification Number	VF1R8700X63250408

Subject	Report
Client	Dick Automobile e.K., Otto-Hahn-Str. 4-6, DE-36179 Bebra
Inspection date/location	11.04.2024 Dick Automobile e.K., Ernst-Abbe-Str. 2, DE-36179 Bebra
Registration number	HF-JR 294
Vehicle type	Saloon
Manufacturer	Renault
Model / Sales description	Captur ENERGY dCi 90 Intens 1.5
Key numbers HSN/TSN	3333 / AZY
Vehicle identification number	VF1R8700X63250408
Previous owners	1
First registration	25.06.2019
Mileage	145.154 km
Colour / Colour Code	Weiss Metallic
Fuel Type	Diesel
Cubic Capacity / Power	1.461 cm ³ / 66 kW
Number of doors / seats	5 / 5
Transmission	Manual gearbox
Number of keys	2
Last maintenance	08.03.2023 / 126.789 km
Next vehicle inspection	01.05.2024
Service documentation	Available
Trailer coupling	No
Rain sensor	Available
Operating manual	Available
Repainting	Not Found
	Plastic parts could not be evaluated by means of paint thickness measurement.
Inspection Condition

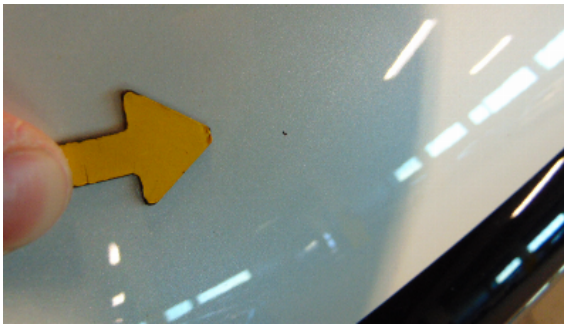
Nr.	Component	Damage	Severity	Comment
1	Bonnet	Stone chip	Slight	
2	Door RR	Scratch	Slight	
3	Bumper rear	Scratch	Slight	
4	Aluminium rim FR	Scratch	Medium
