REPORTNUMBER: 202504-30041

Report

Subject	Report
Inspection date/location	10.04.2025 Dick Automobile e.K., Ernst-Abbe-Str. 2, DE-36179 Bebra
Client	Dick Automobile e.K., Otto-Hahn-Str. 4-6, DE-36179 Bebra
Registration number	
Vehicle Identification Number	WAUZZZGA9PA008955

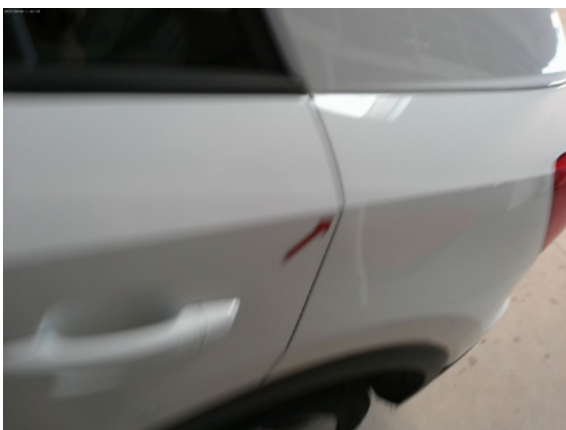
Image 1: Siehe Pos.1

Nr.	Component	Damage	Severity	Comment
1	Door RL	Scratch	Slight	
2	Bumper rear	Scratch	Slight	
3	Roof	Dent	Slight	
4	Aluminium rim FR	Scratch	Slight
