Gerlach & Schröder GbR
Nürnberger Str. 34
DE-36199 Rotenburg a.d. Fulda/Lisp.

REPORTNUMBER: 202404-26120

Report

Subject	Report
Inspection date/location	29.04.2024 Dick Automobile e.K., Ernst-Abbe-Str. 2, DE-36179 Bebra
Client	Dick Automobile e.K., Otto-Hahn-Str. 4-6, DE-36179 Bebra
Registration number	MA-OK 81
Vehicle Identification Number	TMAH3513GLJ124388

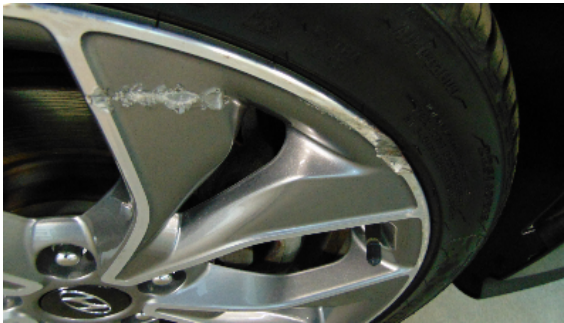
Image 1: siehe pos.1

Nr.	Component	Damage	Severity	Comment
1	Aluminium rim FR	Scratch	Medium	
2	Aluminium rim RR	Scratch	Medium	
3	Windshield	Stone chip	Slight	
4	Bumper front	Stone chip	Slight
