REPORTNUMBER: 202504-30036

Report

Subject	Report
Inspection date/location	10.04.2025 Dick Automobile e.K., Ernst-Abbe-Str. 2, DE-36179 Bebra
Client	Dick Automobile e.K., Otto-Hahn-Str. 4-6, DE-36179 Bebra
Registration number	
Vehicle Identification Number	LSJWH4094PN037217

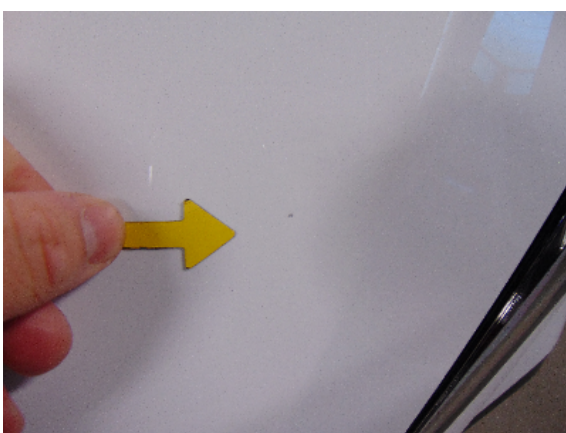
Image 1: siehe pos.1

Nr.	Component	Damage	Severity	Comment
1	Bonnet	Stone chip	Slight	
2	Bumper front	Stone chip	Slight
