REPORTNUMBER: 202409-27590

Report

Subject	Report
Inspection date/location	12.09.2024 Dick Automobile e.K., Ernst-Abbe-Str. 2, DE-36179 Bebra
Client	Dick Automobile e.K., Otto-Hahn-Str. 4-6, DE-36179 Bebra
Registration number	M-LQ 704
Vehicle Identification Number	ZFA26300006N79172

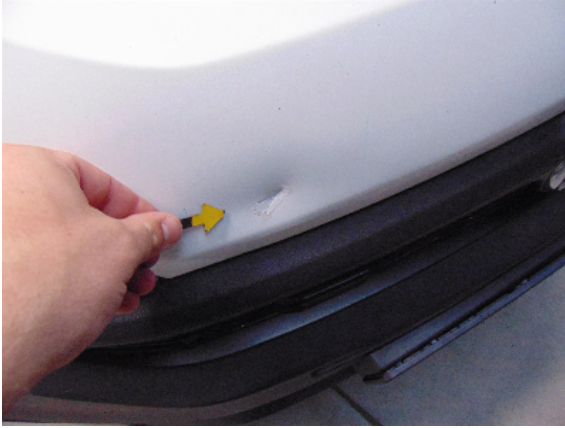
Image 1: siehe pos.1

Nr.	Component	Damage	Severity	Comment
1	Bonnet	Dent	Medium	
2	Bumper front	Scratch	Slight	
3	Fender ri	Dent	Medium	
4	Bumper rear	Scratch	Slight	
5	Door FL	Scratch	Slight
