REPORTNUMBER: 202404-25925

## Report

<b>Subject</b>	Report
<b>Inspection date/location</b>	15.04.2024   Dick Automobile e.K., Ernst-Abbe-Str. 2, DE-36179 Bebra
<b>Client</b>	Dick Automobile e.K., Otto-Hahn-Str. 4-6, DE-36179 Bebra
<b>Registration number</b>	BT-KS 3003
<b>Vehicle Identification Number</b>	VXEVFEHZ8LZ002670

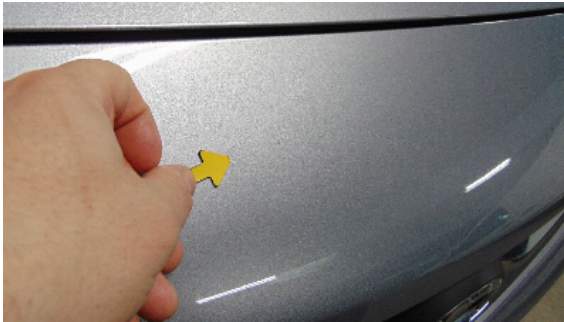
Image 1: siehe pos.1

Nr.	Component	Damage	Severity	Comment
1	Bumper front	Stone chip	Slight	
2	Door FR	Scratch	Slight	
3	Door RR	Scratch	Slight	
4	Bumper rear	Scratch	Slight	
5	Door FL	Scratch	Slight

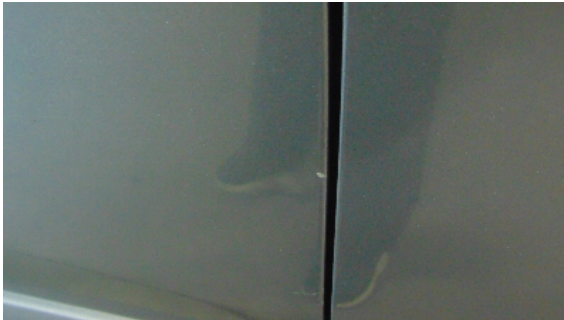
Image 3: siehe pos.3

- Door r.r.; ~ 170µm
- Bumper re.;

A sample-like paint thickness measurement showed an increased paint thickness, which is almost certainly due to a repaired damage.
