Gerlach & Schröder GbR
Nürnberger Str. 34
DE-36199 Rotenburg a.d. Fulda/Lisp.

REPORTNUMBER: 202602-32657

Report

Subject	Report
Inspection date/location	16.02.2026 Dick Automobile e.K., Ernst-Abbe-Str. 2, DE-36179 Bebra
Client	Dick Automobile e.K., Otto-Hahn-Str. 4-6, DE-36179 Bebra
Registration number	HK-BV 600E
Vehicle Identification Number	W1N1673171A608362

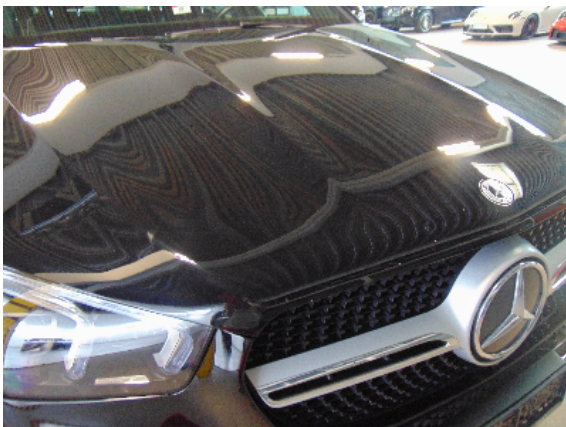
Image 1:

Nr.	Component	Damage	Severity	Comment
1	Bonnet	Stone chip	Slight	
2	Bumper front	Stone chip	Slight	
3	Windshield	Stone chip	Slight
