REPORTNUMBER: 202404-26028

## Report

<b>Subject</b>	Report
<b>Inspection date/location</b>	22.04.2024   Dick Automobile e.K., Ernst-Abbe-Str. 2, DE-36179 Bebra
<b>Client</b>	Dick Automobile e.K., Otto-Hahn-Str. 4-6, DE-36179 Bebra
<b>Registration number</b>	KR-CD444
<b>Vehicle Identification Number</b>	TMBJG7NE1J0360750

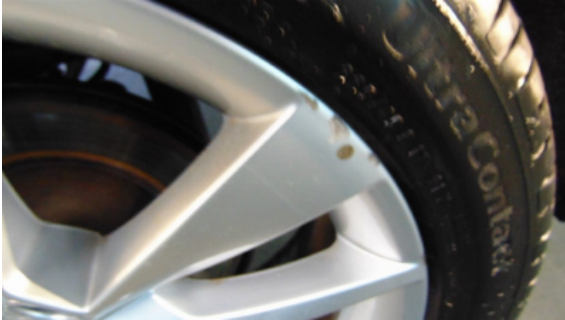
Image 1: Siehe Pos.1

Nr.	Component	Damage	Severity	Comment
1	Aluminium rim RL	Scratch	Slight	
2	Aluminium rim RR	Scratch	Slight	
3	Bonnet	Stone chip	Slight	
4	Bumper front		Slight	
5	Windshield	Stone chip	Slight	
6	Door entry FL	Scratch	Slight	
7	Door RL		Medium	
8	Door entry RL	Scratch	Slight	
9	Side panel left	Dent	Slight	
10	Bumper rear	Scratch	Slight	
11	Side panel right	Dent	Slight	
12	Door RR	Stone chip	Slight
