REPORTNUMBER: 202404-25964

Report

Subject	Report
Inspection date/location	17.04.2024 Dick Automobile e.K., Ernst-Abbe-Str. 2, DE-36179 Bebra
Client	Dick Automobile e.K., Otto-Hahn-Str. 4-6, DE-36179 Bebra
Registration number	REH-AU 376
Vehicle Identification Number	YV1UZA8VDK1334405

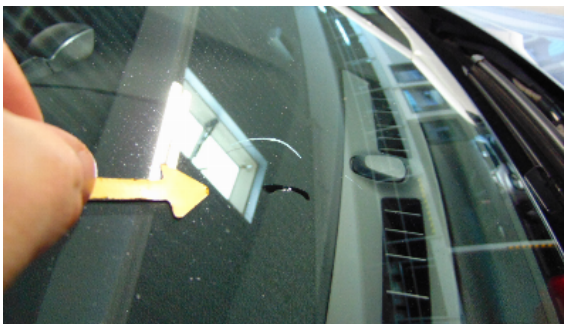
Nr.	Component	Damage	Severity	Comment
1	Windshield	Stone chip	Slight	
2	Bonnet	Stone chip	Slight	
3	Bumper front	Stone chip	Slight	
4	Tailgate panel	Scratch	Slight
