REPORTNUMBER: 202404-26114

## Report

| <b>Registration number</b> | K-UM1098 |

| <b>Model / Sales description</b> | Vito 114 CDI Komp. |

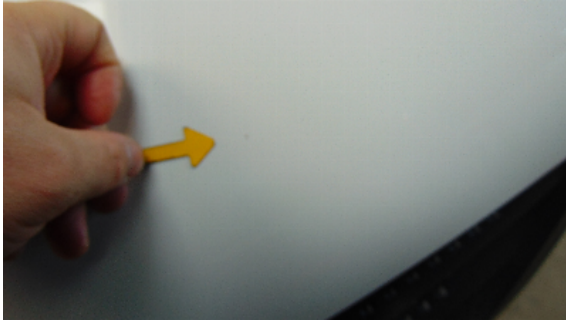
Image 1: siehe pos.1

| Nr. | Component | Damage | Severity | Comment |
|---|---|---|---|---|
| 1 | Bonnet | Stone chip | Slight | |

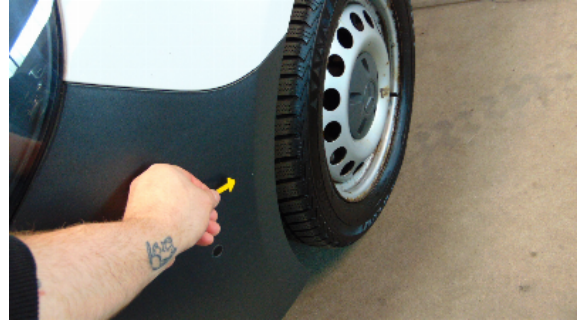
Image 2: siehe pos.2

| Nr. | Component | Damage | Severity | Comment |
|---|---|---|---|---|
| 2 | Bumper front | Stone chip | Slight | |

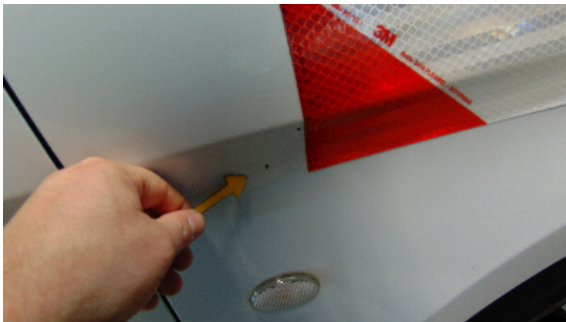
Image 3: siehe pos.3

| Nr. | Component | Damage | Severity | Comment |
|---|---|---|---|---|
| 3 | Fender ri | Scratch | Slight | |

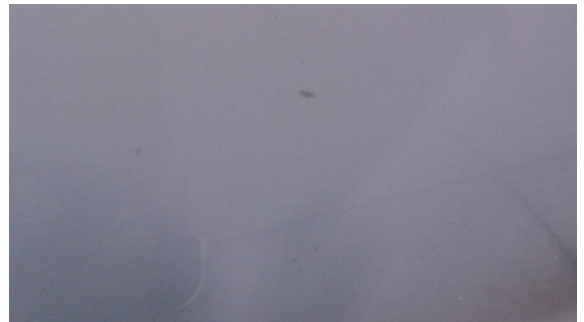
Image 4: siehe pos.4

| Nr. | Component | Damage | Severity | Comment |
|---|---|---|---|---|
| 4 | Door FR | Scratch | Slight | |

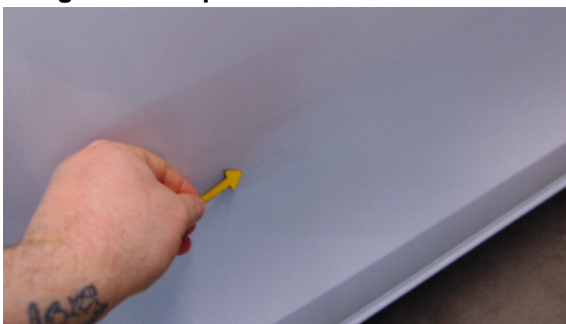
Image 5: siehe pos.5

| Nr. | Component | Damage | Severity | Comment |
|---|---|---|---|---|
| 5 | Door RR | Scratch | Slight | |

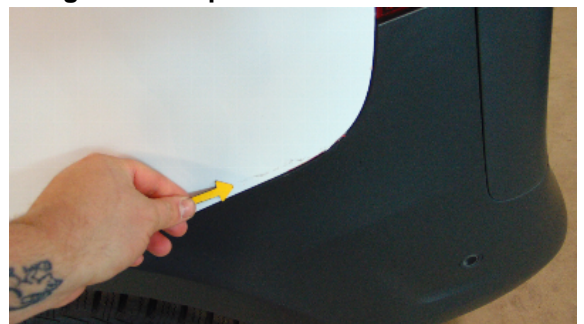
Image 6: siehe pos.6

| Nr. | Component | Damage | Severity | Comment |
|---|---|---|---|---|
| 6 | Side panel left | Scratch | Slight | |

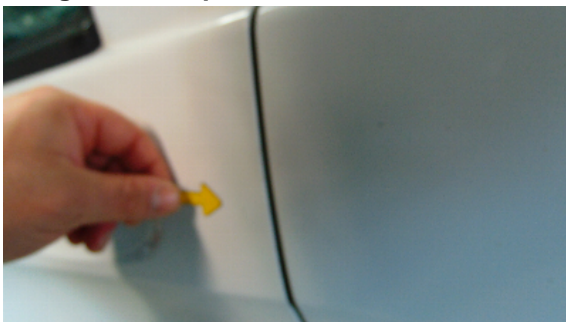
Image 7: siehe pos.7

| Nr. | Component | Damage | Severity | Comment |
|---|---|---|---|---|
| 7 | Door FL | Scratch | Slight | |
