REPORTNUMBER: 202409-27646

Report

Subject	Report
Inspection date/location	18.09.2024 Dick Automobile e.K., Ernst-Abbe-Str. 2, DE-36179 Bebra
Client	Dick Automobile e.K., Otto-Hahn-Str. 4-6, DE-36179 Bebra
Registration number	R-UH836E
Vehicle Identification Number	LSJA24394MN091989

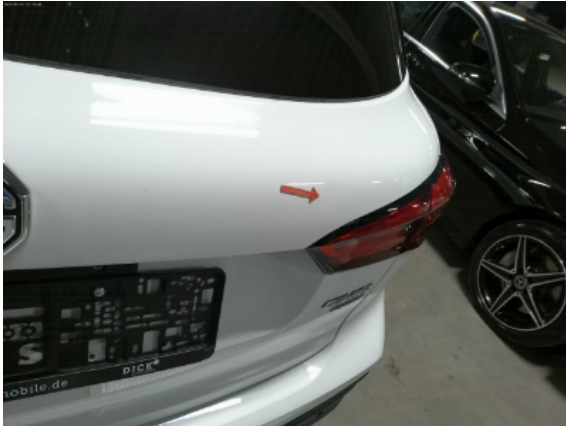
Image 3: Siehe Pos.3

Nr.	Component	Damage	Severity	Comment
1	Windshield	Stone chip	Medium	
2	Bonnet	Stone chip	Slight	
3	Tailgate	Dent	Slight	
4	Door RR	Scratch	Slight
