REPORTNUMBER: 202501-29216

Report

Subject	Report
Inspection date/location	30.01.2025 Dick Automobile e.K., Ernst-Abbe-Str. 2, DE-36179 Bebra
Client	Dick Automobile e.K., Otto-Hahn-Str. 4-6, DE-36179 Bebra
Registration number	B-W1067
Vehicle Identification Number	WV1ZZZ2KZKX112321

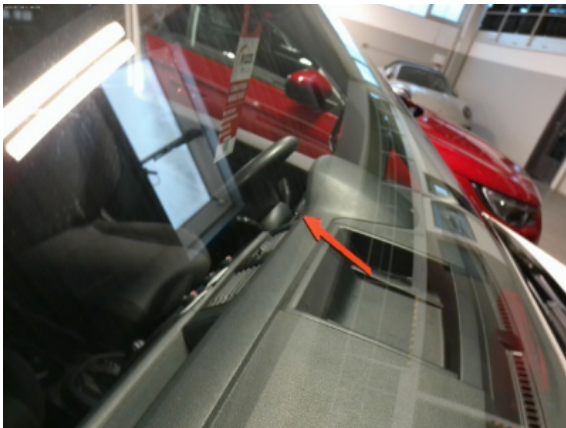
Image 1: Siehe Pos.1

Nr.	Component	Damage	Severity	Comment
1	Windshield	Stone chip	Slight	
2	Bumper rear	Scratch	Slight	
3	Mirror cap right	Scratch	Severe
