REPORTNUMBER: 202404-25972

Report

Subject	Report
Inspection date/location	17.04.2024 Dick Automobile e.K., Ernst-Abbe-Str. 2, DE-36179 Bebra
Client	Dick Automobile e.K., Otto-Hahn-Str. 4-6, DE-36179 Bebra
Registration number	HB-N8699
Vehicle Identification Number	WF0PXXGCHPLE24546

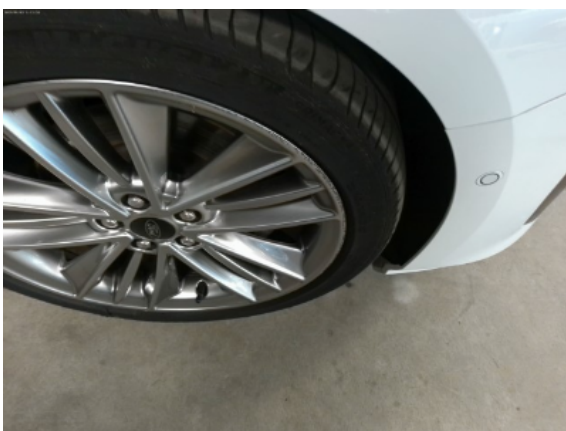
Image 1: Siehe Pos.1

Nr.	Component	Damage	Severity	Comment
1	Aluminium rim FR	Scratch	Severe	
2	Windshield	Stone chip	Slight	
3	Bonnet		Severe	
4	Roof		Severe	
5	Bumper front	Stone chip	Slight	
6	Bumper front	Scratch	Medium	
7	Door FL	Scratch	Slight	
8	Bumper rear	Scratch	Slight	
9	Fender ri	Stone chip	Slight	
10	Tire FR		Severe
