REPORTNUMBER: 202406-26845

Report

Subject	Report
Client	Dick Automobile e.K., Otto-Hahn-Str. 4-6, DE-36179 Bebra
Inspection date/location	26.06.2024 Dick Automobile e.K., Ernst-Abbe-Str. 2, DE-36179 Bebra
Registration number	
Vehicle type	Van
Manufacturer	Mercedes-Benz
Model / Sales description	Vito 114 Mixto
Key numbers HSN/TSN	/
Vehicle identification number	WDF44770313625576
Previous owners	
First registration	30.08.2019
Mileage	129.821 km
Colour / Colour Code	
Fuel Type	Diesel
Cubic Capacity / Power	2.143 cm ³ / 100 kW
Number of doors / seats	4 / 4
Transmission	Manual gearbox
Number of keys	1
Last maintenance	Unknown
Next vehicle inspection	
Service documentation	Nonexistent
Trailer coupling	Fix
Rain sensor	Unavailable
Operating manual	Available
Repainting	Found Plastic parts could not be evaluated by means of paint thickness measurement.
Inspection Condition	non-dismantled, roadworthy, traffic safe

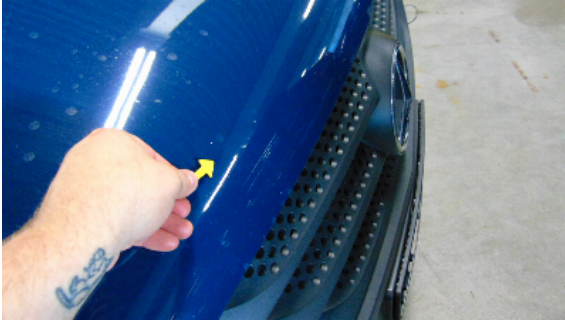
Image 1: siehe pos.1

Nr.	Component	Damage	Severity	Comment
1	Bonnet	Stone chip	Slight	
2	Bumper front	Scratch	Slight	
3	Mirror cap right	Scratch	Slight	
4	Door FR	Scratch	Slight	
5	Door RR	Scratch	Slight	
6	Bumper rear	Scratch	Slight	
7	Side panel left	Scratch	Slight	
8	Fender le	Scratch	Slight	
9	Headlight FR	Scratch	Medium	
10	Headlight FL	Scratch	Medium
