REPORTNUMBER: 202409-27515

Report

Subject	Report
Inspection date/location	05.09.2024 Dick Automobile e.K., Ernst-Abbe-Str. 2, DE-36179 Bebra
Client	Dick Automobile e.K., Otto-Hahn-Str. 4-6, DE-36179 Bebra
Registration number	HEF PW 100
Vehicle Identification Number	WF0KXXERJKDR74284

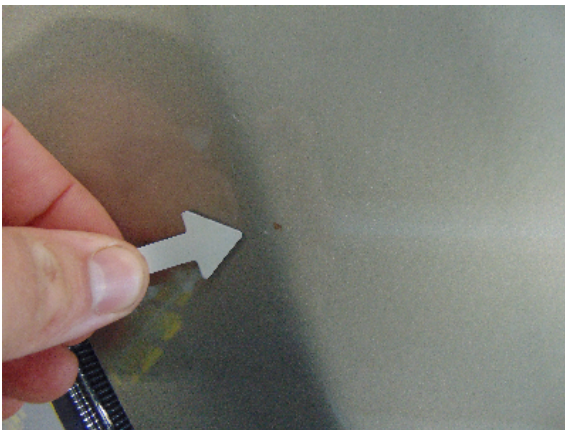
Image 1: siehe pos.1

Nr.	Component	Damage	Severity	Comment
1	Bonnet	Stone chip	Slight	
2	Bumper front	Deformation	Severe	
3	Mirror cap right	Scratch	Slight	
4	Bumper rear	Deformation	Severe	
5	Bumper rear	Scratch	Medium	
6	Door FL	Scratch	Slight	
7	Fender le	Deformation	Severe
