REPORTNUMBER: 202206-19481

## Report

<b>Subject</b>	Report
<b>Inspection date/location</b>	09.06.2022   Dick Automobile e.K., Ernst-Abbe-Str. 2, DE-36179 Bebra
<b>Client</b>	Dick Automobile e.K., Otto-Hahn-Str. 4-6, DE-36179 Bebra
<b>Registration number</b>	
<b>Vehicle Identification Number</b>	WDD2052871F219820

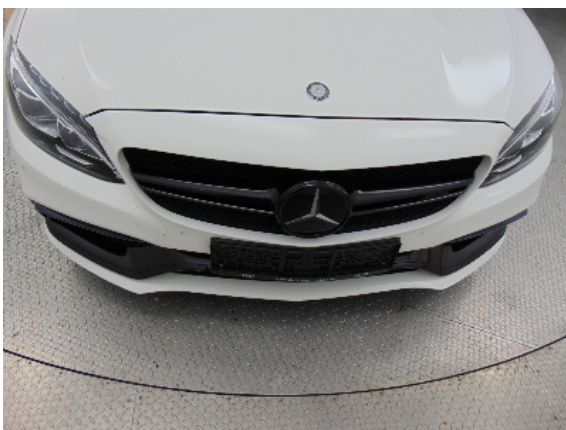
Image 1: Siehe Pos.1

Nr.	Component	Damage	Severity	Comment
1	Bumper front	Stone chip	Slight	
2	Bonnet	Stone chip	Slight	
3	Windshield	Stone chip	Slight	
4	Door panel FL		Slight	
5	Seat FL		Severe	
6			Slight	
7	Aluminium rim RL		Slight	
8	Bumper rear		Slight	
9	Tailgate panel		Slight	
10	Door panel RR		Slight	
11	Aluminium rim RR		Slight	
12	Aluminium rim FR		Slight	
13	Tire FR		Severe

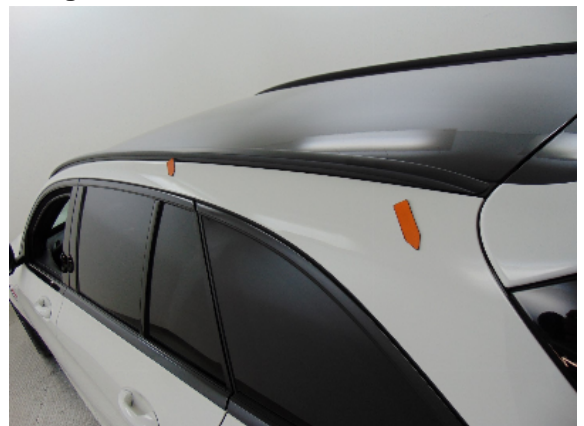
Image 14: Siehe Pos.14

14

Slight
