REPORTNUMBER: 202409-27573

## Report

<b>Subject</b>	Report
<b>Inspection date/location</b>	11.09.2024   Dick Automobile e.K., Ernst-Abbe-Str. 2, DE-36179 Bebra
<b>Client</b>	Dick Automobile e.K., Otto-Hahn-Str. 4-6, DE-36179 Bebra
<b>Registration number</b>	
<b>Vehicle Identification Number</b>	WAUZZZF34K1057783

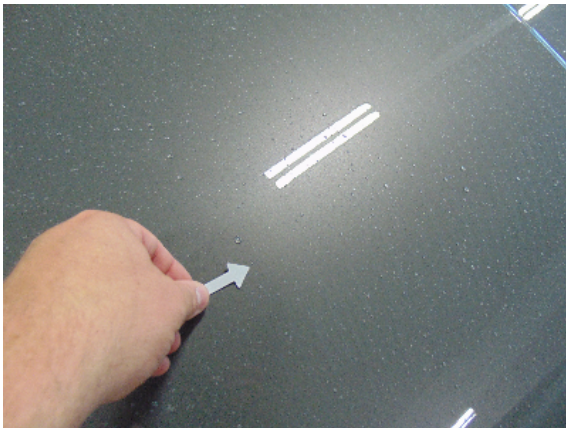
Image 1: siehe pos.1

Nr.	Component	Damage	Severity	Comment
1	Bonnet	Stone chip	Slight	
2	Bumper front	Stone chip	Slight
