REPORTNUMBER: 202404-25998

Report

Subject	Report
Inspection date/location	19.04.2024 Dick Automobile e.K., Ernst-Abbe-Str. 2, DE-36179 Bebra
Client	Dick Automobile e.K., Otto-Hahn-Str. 4-6, DE-36179 Bebra
Registration number	SU-MY 130
Vehicle Identification Number	WAUZZZFY5L2112233

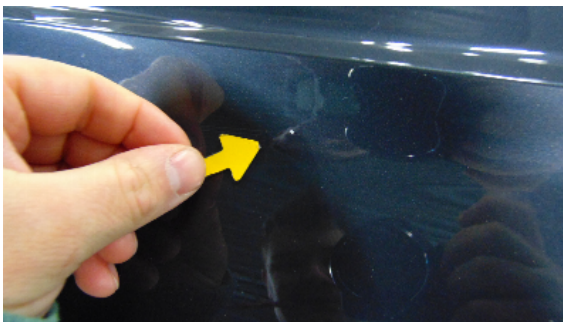
Image 1: siehe pos.1

Nr.	Component	Damage	Severity	Comment
1	Bonnet	Stone chip	Slight	
2	Bumper front	Stone chip	Slight	
3	Door FR	Scratch	Slight	
4	Door RR	Scratch	Slight	
5	Tailgate panel	Scratch	Slight	
6	Bumper rear	Scratch	Slight	
7	Door FL	Scratch	Slight	
8	Fender le	Scratch	Slight
