REPORTNUMBER: 202404-25915

## Report

<b>Subject</b>	Report
<b>Inspection date/location</b>	12.04.2024   Dick Automobile e.K., Ernst-Abbe-Str. 2, DE-36179 Bebra
<b>Client</b>	Dick Automobile e.K., Otto-Hahn-Str. 4-6, DE-36179 Bebra
<b>Registration number</b>	
<b>Vehicle Identification Number</b>	KNAGV81FBK5037895

<b>Subject</b>	Report
<b>Client</b>	Dick Automobile e.K., Otto-Hahn-Str. 4-6, DE-36179 Bebra
<b>Inspection date/location</b>	12.04.2024   Dick Automobile e.K., Ernst-Abbe-Str. 2, DE-36179 Bebra
<b>Registration number</b>	
<b>Vehicle type</b>	Estate Car
<b>Manufacturer</b>	Kia
<b>Model / Sales description</b>	Optima Sportswagon 2.0 GDI Plug-In Hybrid Spirit
<b>Key numbers HSN/TSN</b>	/
<b>Vehicle identification number</b>	KNAGV81FBK5037895
<b>Previous owners</b>	1
<b>First registration</b>	26.06.2019
<b>Mileage</b>	172.316 km
<b>Colour / Colour Code</b>	Weiss
<b>Fuel Type</b>	Hybrid/Diesel
<b>Cubic Capacity / Power</b>	1.999 cm <sup>3</sup> / 113 kW
<b>Number of doors / seats</b>	5 / 5
<b>Transmission</b>	Automatic transmission
<b>Number of keys</b>	2
<b>Last maintenance</b>	20.12.2023 / 165.000 km
<b>Next vehicle inspection</b>	30.05.2024
<b>Service documentation</b>	Ava

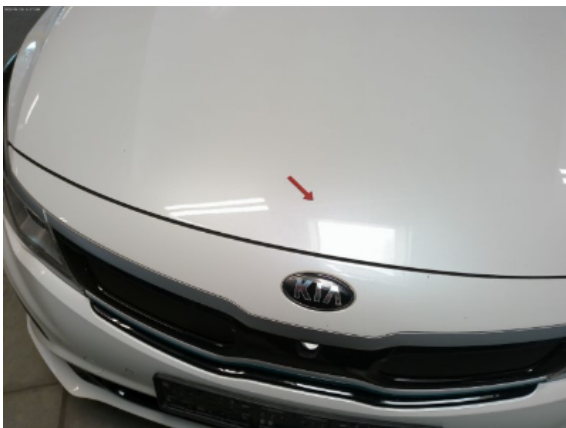
Image 1: Siehe Pos.1

Nr.	Component	Damage	Severity	Comment
1	Bonnet	Stone chip	Slight	
2	Bumper front	Stone chip	Slight	
3	Door FL	Scratch	Slight	
4	Bumper rear	Scratch	Slight	
5	Door RR	Scratch	Slight	
6	Side panel right	Dent	Slight
