REPORTNUMBER: 202404-25902

Report

Subject	Report
Inspection date/location	12.04.2024 Dick Automobile e.K., Ernst-Abbe-Str. 2, DE-36179 Bebra
Client	Dick Automobile e.K., Otto-Hahn-Str. 4-6, DE-36179 Bebra
Registration number	
Vehicle Identification Number	WDD2132161A753758

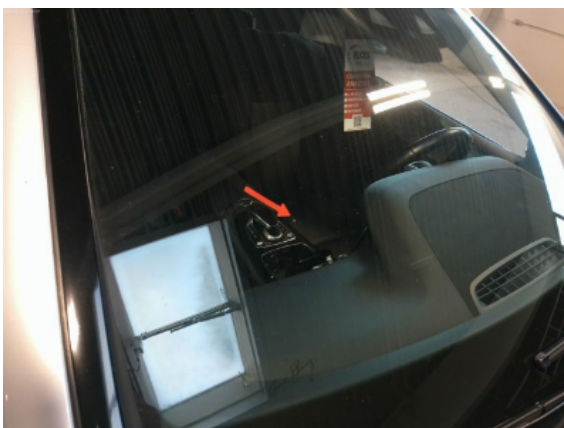
Image 1: Siehe Pos.1

Nr.	Component	Damage	Severity	Comment
1	Windshield	Stone chip	Slight	
2	Bonnet	Stone chip	Slight	
3	Bumper front	Stone chip	Slight	
4	Door FL	Scratch	Slight	
5	Door entry FL	Scratch	Slight	
6	Bumper rear	Scratch	Slight	
7	Fender ri	Scratch	Slight
