REPORTNUMBER: 202402-25187

Report

Subject	Report
Inspection date/location	15.02.2024 Dick Automobile e.K., Ernst-Abbe-Str. 2, DE-36179 Bebra
Client	Dick Automobile e.K., Otto-Hahn-Str. 4-6, DE-36179 Bebra
Registration number	MA-BB 393
Vehicle Identification Number	2FMTK4V30JBB01634

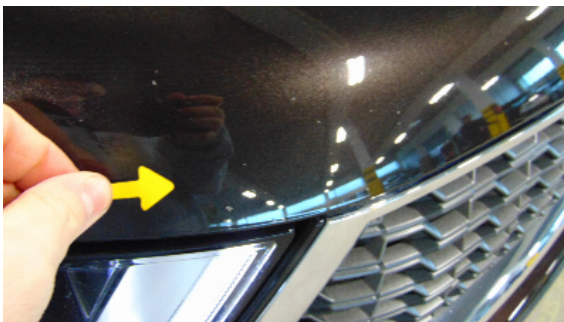
Image 1: siehe pos.1

Nr.	Component	Damage	Severity	Comment
1	Bonnet	Stone chip	Slight	
2	Bumper front	Stone chip	Slight	
3	Fender ri	Scratch	Slight	
4	Windshield	Scratch	Slight	
5	Door FR	Scratch	Slight	
6	Tailgate panel	Scratch	Slight	
7	Fender le	Scratch	Slight
