REPORTNUMBER: 202403-25700

## Report

<b>Subject</b>	Report
<b>Inspection date/location</b>	27.03.2024   Dick Automobile e.K., Ernst-Abbe-Str. 2, DE-36179 Bebra
<b>Client</b>	Dick Automobile e.K., Otto-Hahn-Str. 4-6, DE-36179 Bebra
<b>Registration number</b>	D-HB 624
<b>Vehicle Identification Number</b>	WAUZZZ4M7KD039174

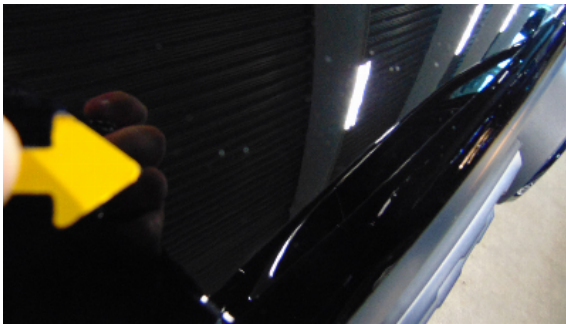
Image 1: siehe pos.1

Nr.	Component	Damage	Severity	Comment
1	Bonnet	Stone chip	Slight	
2	Bumper front	Stone chip	Slight	
3	Tailgate	Scratch	Slight	
4	Door RL	Scratch	Slight	
5	Door FL	Scratch	Slight	
6	Mirror cap left	Scratch	Slight
