REPORTNUMBER: 202409-27634

## Report

<b>Subject</b>	Report
<b>Inspection date/location</b>	17.09.2024   Dick Automobile e.K., Ernst-Abbe-Str. 2, DE-36179 Bebra
<b>Client</b>	Dick Automobile e.K., Otto-Hahn-Str. 4-6, DE-36179 Bebra
<b>Registration number</b>	ME-SW 1085
<b>Vehicle Identification Number</b>	W1N2533151F972763

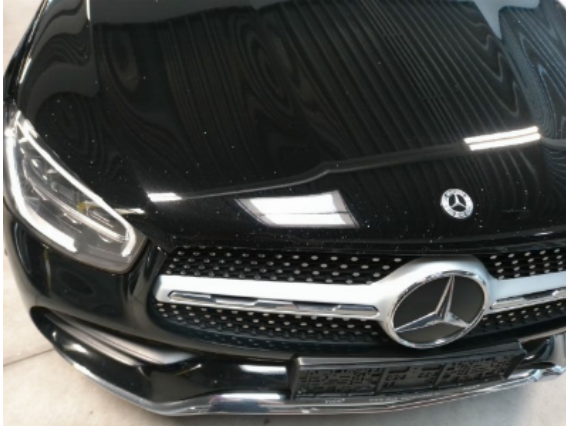
Image 1: Siehe Pos.1

Nr.	Component	Damage	Severity	Comment
1	Bonnet	Stone chip	Severe	
2	Bumper front	Stone chip	Slight	
3	Fender le	Stone chip	Slight	
4	A-pillar left	Stone chip	Medium	
5	Side panel left	Stone chip	Slight	
6	Door FL	Scratch	Slight	
7	Seat FL	Crack	Medium	
8	Bumper rear	Scratch	Severe	
9	Door RR	Scratch	Slight	
10	Door FR	Stone chip	Slight	
11	Mirror cap right	Stone chip	Slight	
12	A-pillar right	Stone chip	Medium

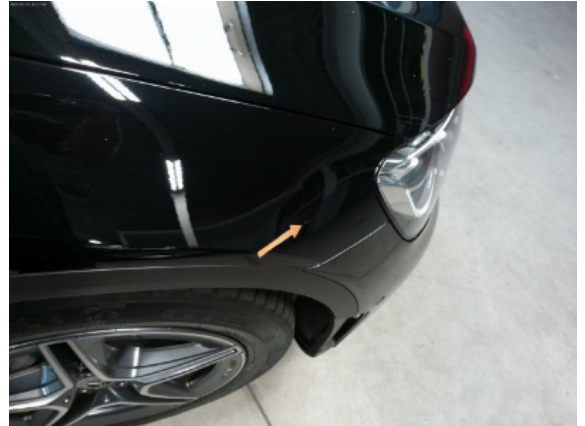
Image 14: Siehe Pos.13

13 Fender ri Stone chip Slight
