REPORTNUMBER: 202401-24986

Report

Subject	Report
Client	Dick Automobile e.K., Otto-Hahn-Str. 4-6, DE-36179 Bebra
Inspection date/location	29.01.2024 Dick Automobile e.K., Ernst-Abbe-Str. 2, DE-36179 Bebra
Registration number	F-BO 999
Vehicle type	Estate Car
Manufacturer	VW
Model / Sales description	California t6.1 dsg BEACH CAMPER Aufstelldach 0.2
Key numbers HSN/TSN	0603 / BVD
Vehicle identification number	WV2ZZZ7HZJH183509
Previous owners	1
First registration	09.08.2018
Mileage	165.809 km
Colour / Colour Code	SCHWARZ
Fuel Type	Diesel
Cubic Capacity / Power	1.968 cm ³ / 150 kW
Number of doors / seats	5 / 5
Transmission	Automatic transmission
Number of keys	2
Last maintenance	Unknown
Next vehicle inspection	01.09.2025
Service documentation	Nonexistent
Trailer coupling	Detachable
Rain sensor	Available
Operating manual	Available
Repainting	Found
	Plastic parts could not be evaluated by means of paint thickness measurement.
Inspection Condition	non-dismantled, roadworthy, traffic safe

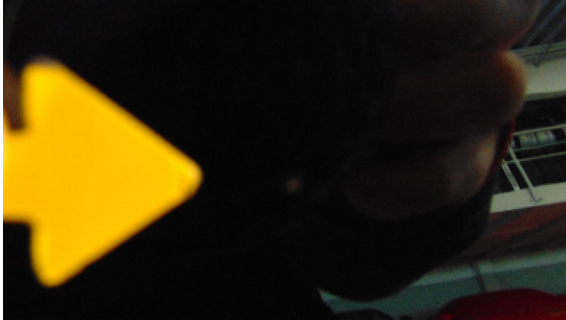
Image 1: siehe pos.1

Nr.	Component	Damage	Severity	Comment
1	Bonnet	Stone chip	Slight	
2	Bumper front	Stone chip	Slight	
3	Mirror cap right	Scratch	Slight	
4	Side panel left	Scratch	Slight	
5	Door FL	Scratch	Slight
