Gerlach & Schröder GbR
Nürnberger Str. 34
DE-36199 Rotenburg a.d. Fulda/Lisp.

REPORTNUMBER: 202403-25742

Report

Subject	Report
Inspection date/location	28.03.2024 Dick Automobile e.K., Ernst-Abbe-Str. 2, DE-36179 Bebra
Client	Dick Automobile e.K., Otto-Hahn-Str. 4-6, DE-36179 Bebra
Registration number	B-KP 5900
Vehicle Identification Number	WF0PXXGCHPKC32937

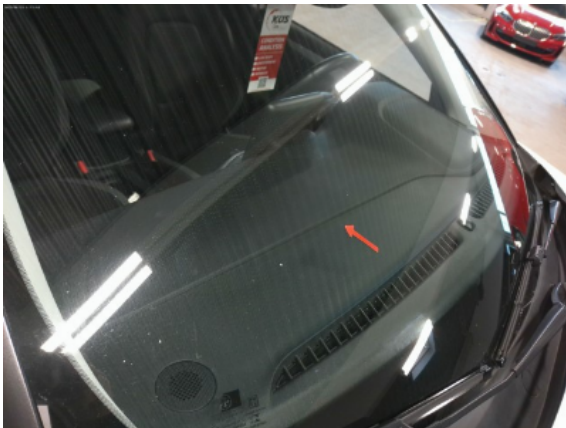
Image 1: Siehe Pos.1

Nr.	Component	Damage	Severity	Comment
1	Windshield	Stone chip	Slight	
2	Bonnet	Dent	Slight	
3	Bonnet	Stone chip	Slight	
4	Bumper front	Scratch	Slight	
5	Door FL	Scratch	Slight	
6	Bumper rear	Scratch	Medium
