REPORTNUMBER: 202410-27826

Report

Subject	Report
Client	Dick Automobile e.K., Otto-Hahn-Str. 4-6, DE-36179 Bebra
Inspection date/location	02.10.2024 Dick Automobile e.K., Ernst-Abbe-Str. 2, DE-36179 Bebra
Registration number	
Vehicle type	Minivan/Minibus
Manufacturer	Ford
Model / Sales description	S-Max 2.0 EcoBlue TREND 2.0
Key numbers HSN/TSN	8566 / BKM
Vehicle identification number	WF0JXXWPCJLD11601
Previous owners	1
First registration	26.10.2020
Mileage	187.485 km
Colour / Colour Code	Frozen White
Fuel Type	Diesel
Cubic Capacity / Power	1.995 cm ³ / 110 kW
Number of doors / seats	5 / 5
Transmission	Manual gearbox
Number of keys	2
Last maintenance	04.08.2023 / 143.414 km
Next vehicle inspection	01.12.2025
Service documentation	Available
Trailer coupling	No
Rain sensor	Available
Operating manual	Available
Repainting	Not Found
	Plastic parts could not be evaluated by means of paint thickness measurement.
Inspection Condition	non-dismantled, roadworthy, traffic safe

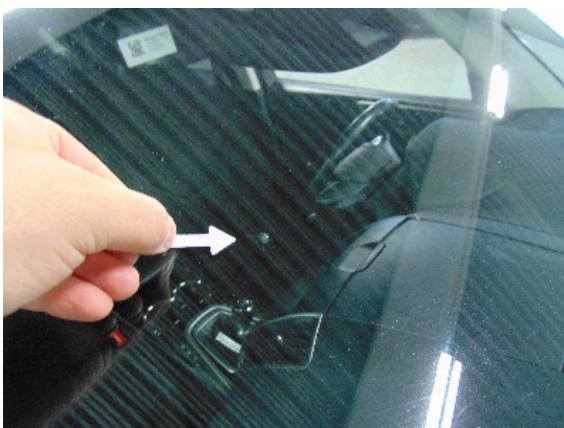
Image 1: siehe pos.1

Nr.	Component	Damage	Severity	Comment
1	Windshield	Stone chip	Medium	
2	Bonnet	Stone chip	Medium	
3	Bumper front	Stone chip	Medium	
4	Door FR	Scratch	Slight	
5	Side panel right	Scratch	Medium	
6	Bumper rear	Scratch	Medium	
7	Side panel left	Scratch	Slight	
8	Door FL	Scratch	Slight	
9	Fender le	Dent	Slight
