REPORTNUMBER: 202409-27679

Report

Subject	Report
Inspection date/location	20.09.2024 Dick Automobile e.K., Ernst-Abbe-Str. 2, DE-36179 Bebra
Client	Dick Automobile e.K., Otto-Hahn-Str. 4-6, DE-36179 Bebra
Registration number	
Vehicle Identification Number	WF0FXXGAHFLK15853

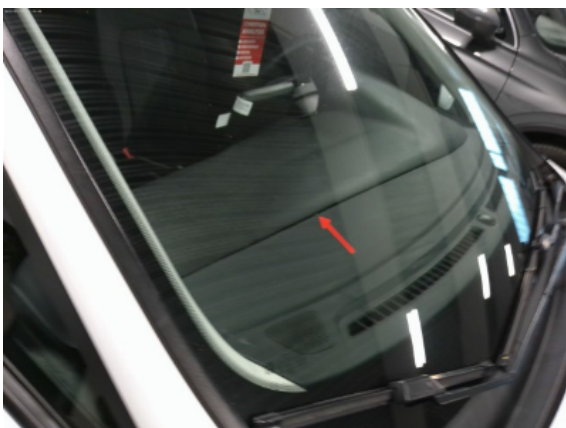
Image 1: Siehe Pos.1

Nr.	Component	Damage	Severity	Comment
1	Windshield	Stone chip	Slight	
2	Bonnet	Stone chip	Slight	
3	Bumper front	Scratch	Medium	
4	Bumper rear	Scratch	Medium	
5	Door FL	Scratch	Medium
