Gerlach & Schröder GbR  
Nürnberger Str. 34  
DE-36199 Rotenburg a.d. Fulda/Lisp.

REPORTNUMBER: 202501-29116

## Report

| <b>Model / Sales description</b> | Transit Custom 320 L1H1 VA Trend 2.0 |

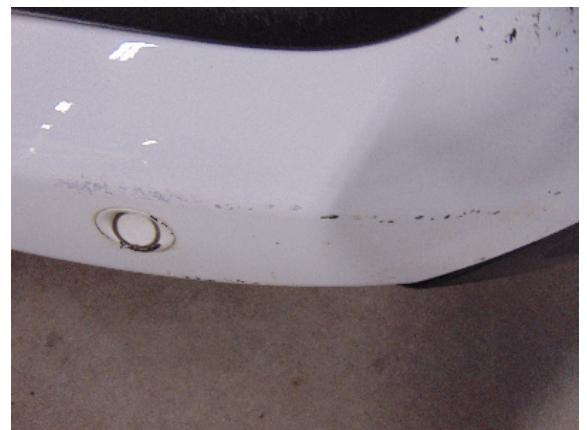
Image 2: siehe pos.2

| Nr. | Component | Damage | Severity | Comment |
|---|---|---|---|---|
| 2 | Bumper front | Scratch | Medium | |

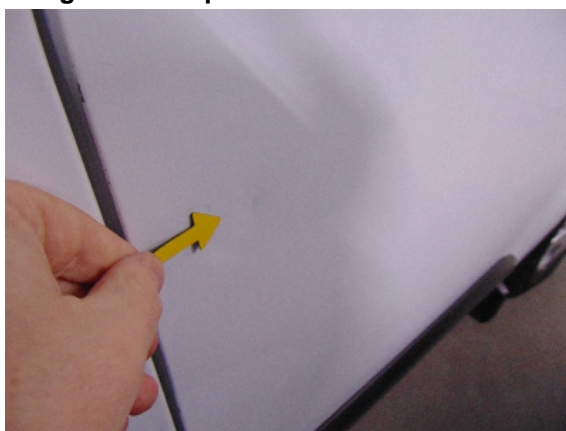
Image 3: siehe pos.3

| Nr. | Component | Damage | Severity | Comment |
|---|---|---|---|---|
| 3 | Door FR | Scratch | Medium | |

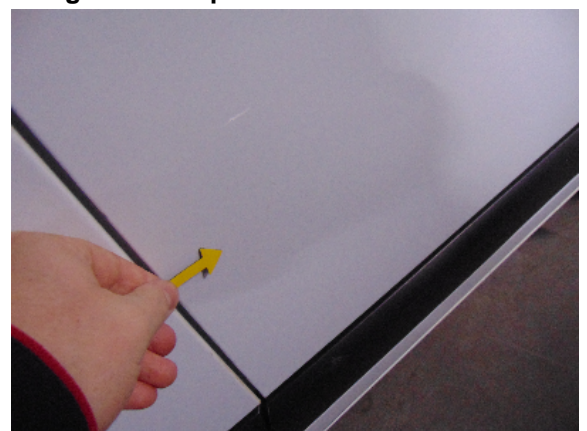
Image 4: siehe pos.4

| Nr. | Component | Damage | Severity | Comment |
|---|---|---|---|---|
| 4 | Door FR | Scratch | Medium | |

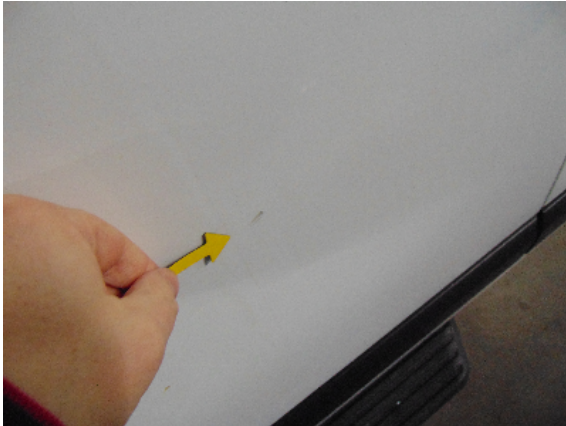
Image 5: siehe pos.5

| Nr. | Component | Damage | Severity | Comment |
|---|---|---|---|---|
| 5 | Door RR | Scratch | Medium | |

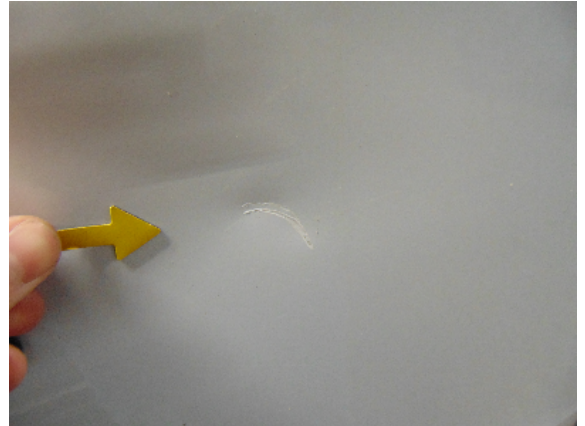
Image 6: siehe pos.6

| Nr. | Component | Damage | Severity | Comment |
|---|---|---|---|---|
| 6 | Tailgate | Scratch | Medium | |

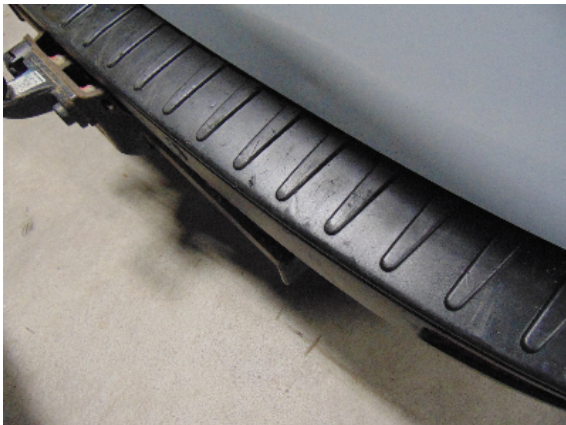
Image 7: siehe pos.7

| Nr. | Component | Damage | Severity | Comment |
|---|---|---|---|---|
| 7 | Bumper rear | Scratch | Medium | |

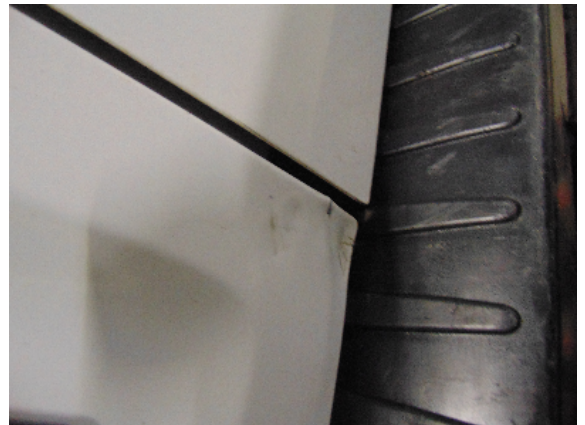
Image 8: siehe pos.8

| Nr. | Component | Damage | Severity | Comment |
|---|---|---|---|---|
| 8 | Tailgate | Dent | Severe | |

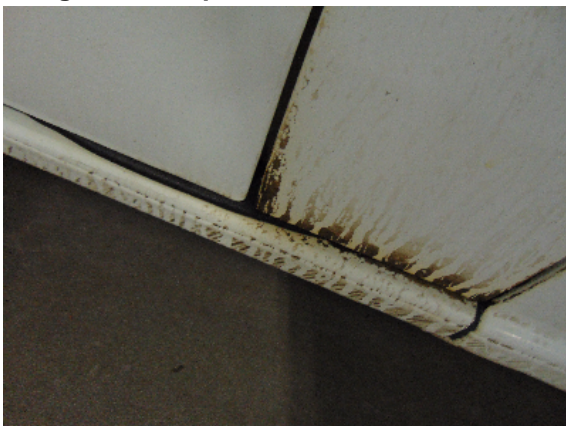
Image 9: siehe pos.9

| Nr. | Component | Damage | Severity | Comment |
|---|---|---|---|---|
| 9 | Door FL | | Severe | |

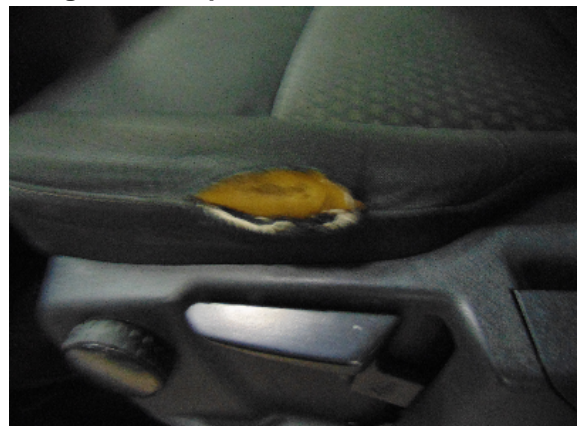
Image 10: siehe pos.10

| Nr. | Component | Damage | Severity | Comment |
|---|---|---|---|---|
| 10 | Seat FL | Crack | Severe | |

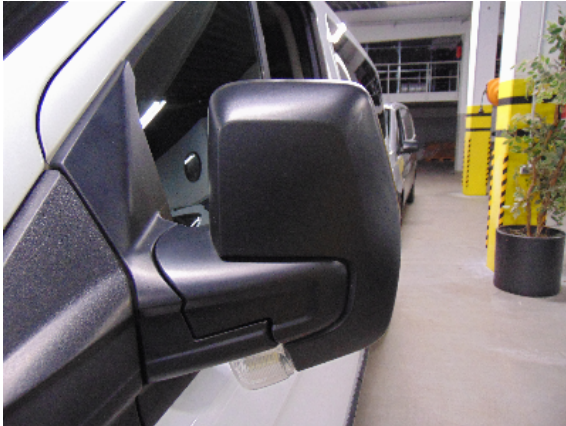
Image 11: siehe pos.11

| Nr. | Component | Damage | Severity | Comment |
|---|---|---|---|---|
| 11 | Mirror cap left | | Severe | |

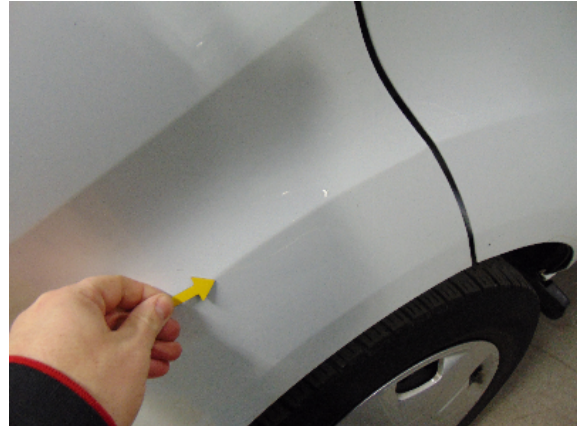
Image 12: siehe pos.12

| Nr. | Component | Damage | Severity | Comment |
|---|---|---|---|---|
| 12 | Fender le | Scratch | Medium | |
