REPORTNUMBER: 202404-25875

## Report

<b>Subject</b>	Report
<b>Inspection date/location</b>	10.04.2024   Dick Automobile e.K., Ernst-Abbe-Str. 2, DE-36179 Bebra
<b>Client</b>	Dick Automobile e.K., Otto-Hahn-Str. 4-6, DE-36179 Bebra
<b>Registration number</b>	M-AX 6615
<b>Vehicle Identification Number</b>	WAUZZZF25MN064650

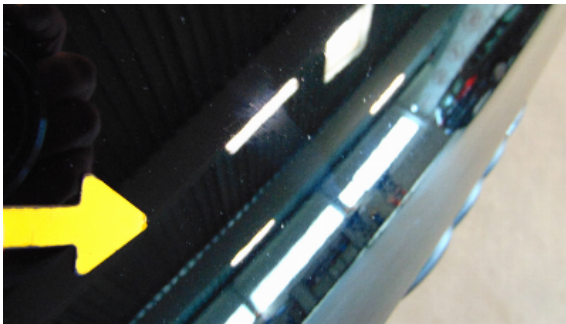
Nr.	Component	Damage	Severity	Comment
1	Bonnet	Stone chip	Slight	
2	Bumper front	Stone chip	Slight	
3	Door FR	Scratch	Slight	
4	Door RR	Scratch	Slight	
5	Bumper rear	Scratch	Slight	
6	Door RL	Scratch	Slight
