REPORTNUMBER: 202404-25841

Report

Subject	Report
Inspection date/location	08.04.2024 Dick Automobile e.K., Ernst-Abbe-Str. 2, DE-36179 Bebra
Client	Dick Automobile e.K., Otto-Hahn-Str. 4-6, DE-36179 Bebra
Registration number	
Vehicle Identification Number	WAUZZZF2XLN092880

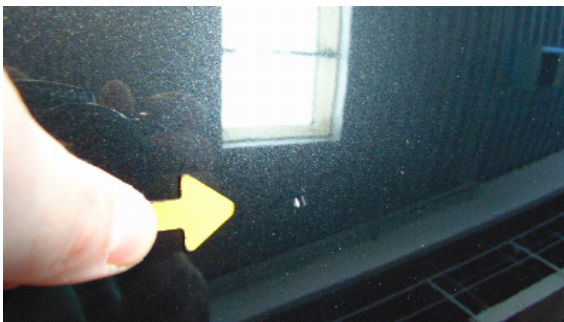
Image 1: siehe pos.1

Nr.	Component	Damage	Severity	Comment
1	Bonnet	Stone chip	Slight	
2	Bumper front	Stone chip	Slight	
3	Fender ri	Scratch	Slight	
4	Tailgate panel	Scratch	Slight
