REPORTNUMBER: 202402-25040

Report

Subject	Report
Inspection date/location	02.02.2024 Dick Automobile e.K., Ernst-Abbe-Str. 2, DE-36179 Bebra
Client	Dick Automobile e.K., Otto-Hahn-Str. 4-6, DE-36179 Bebra
Registration number	K-SN 433
Vehicle Identification Number	W1K1183141N177928

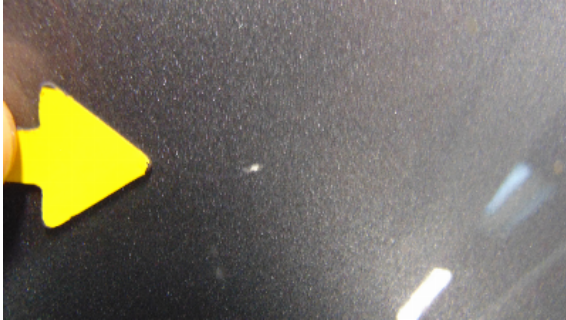
Image 1: siehe pos.1

Nr.	Component	Damage	Severity	Comment
1	Bonnet	Stone chip	Slight	
2	Bumper front	Stone chip	Slight	
3	Windshield	Stone chip	Slight	
4	Door RL	Scratch	Slight	
5	Fender le	Stone chip	Slight
