REPORTNUMBER: 202404-25818

Report

Subject	Report
Client	Dick Automobile e.K., Otto-Hahn-Str. 4-6, DE-36179 Bebra
Inspection date/location	05.04.2024 Dick Automobile e.K., Ernst-Abbe-Str. 2, DE-36179 Bebra
Registration number	RE-SD 109
Vehicle type	Estate Car
Manufacturer	Mercedes-Benz
Model / Sales description	CLA 220 d shooting BRAKE 8G?DCT AMG LINE
Key numbers HSN/TSN	2222 / AGT
Vehicle identification number	W1K1186141N188079
Previous owners	1
First registration	08.01.2021
Mileage	123.755 km
Colour / Colour Code	Schwarz
Fuel Type	Diesel
Cubic Capacity / Power	1.950 cm ³ / 140 kW
Number of doors / seats	5 / 5
Transmission	Automatic transmission
Number of keys	2
Last maintenance	14.09.2023 / 102.096 km
Next vehicle inspection	01.01.2024
Service documentation	Available
Trailer coupling	Swiveling
Rain sensor	Available
Operating manual	Available
Repainting	Not Found Plastic parts could not be evaluated by means of paint thickness measurement.
Inspection Condition	non-dismantled, roadworthy, traffic safe

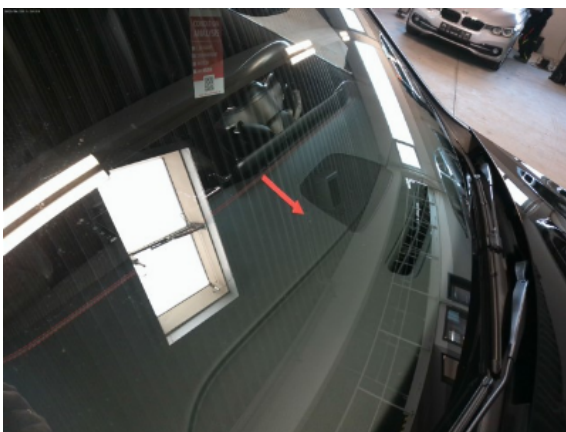
Image 1: Siehe Pos.1

Nr.	Component	Damage	Severity	Comment
1	Windshield	Stone chip	Slight	
2	Bonnet	Stone chip	Medium	
3	Bumper front	Stone chip	Medium	
4	Fender le	Stone chip	Slight	
5	Mirror cap left	Stone chip	Slight	
6	Bumper rear	Scratch	Slight	
7	Mirror cap right	Stone chip	Slight	
8	Fender ri	Stone chip	Slight	
9	Aluminium rim RR	Scratch	Medium
