REPORTNUMBER: 202409-27652

Report

Subject	Report
Inspection date/location	18.09.2024 Dick Automobile e.K., Ernst-Abbe-Str. 2, DE-36179 Bebra
Client	Dick Automobile e.K., Otto-Hahn-Str. 4-6, DE-36179 Bebra
Registration number	MK-MS 1569
Vehicle Identification Number	W1K1186121N238734

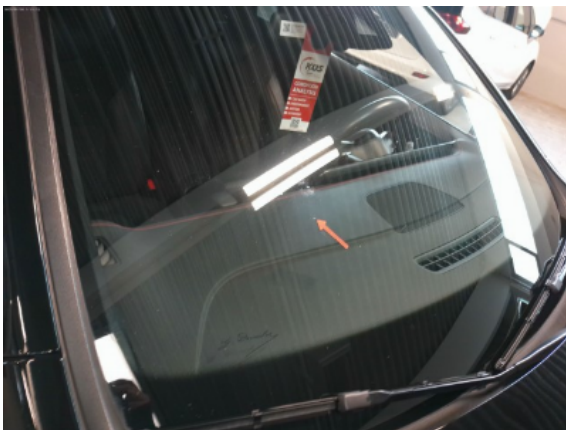
Image 1: Siehe Pos.1

Nr.	Component	Damage	Severity	Comment
1	Windshield	Stone chip	Slight	
2	Bonnet	Stone chip	Slight	
3	Bumper front	Stone chip	Slight	
4	Mirror cap left	Stone chip	Slight	
5	Side panel right	Stone chip	Slight	
6	Mirror cap right	Stone chip	Slight
