REPORTNUMBER: 202409-27762

Report

Subject	Report
Inspection date/location	27.09.2024 Dick Automobile e.K., Ernst-Abbe-Str. 2, DE-36179 Bebra
Client	Dick Automobile e.K., Otto-Hahn-Str. 4-6, DE-36179 Bebra
Registration number	
Vehicle Identification Number	VF3LCYHZPKS061859

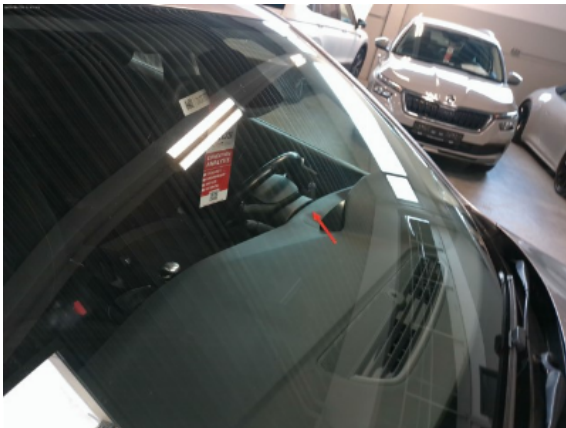
Image 1: Siehe Pos.1

Nr.	Component	Damage	Severity	Comment
1	Windshield	Stone chip	Slight	
2	Bonnet	Stone chip	Slight	
3	Bumper front	Stone chip	Slight	
4	Door FL	Scratch	Slight	
5	Bumper rear	Scratch	Slight	
6	Mirror cap right	Stone chip	Slight
