REPORTNUMBER: 202403-25395

## Report

<b>Subject</b>	Report
<b>Inspection date/location</b>	04.03.2024   Dick Automobile e.K., Ernst-Abbe-Str. 2, DE-36179 Bebra
<b>Client</b>	Dick Automobile e.K., Otto-Hahn-Str. 4-6, DE-36179 Bebra
<b>Registration number</b>	WI-RV 235
<b>Vehicle Identification Number</b>	W1N2476151W027914

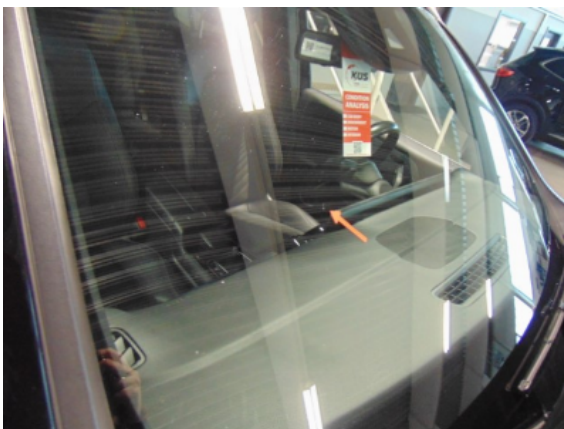
Image 1: Siehe Pos.1

Nr.	Component	Damage	Severity	Comment
1	Windshield	Stone chip	Slight	
2	Bonnet	Stone chip	Medium	
3	Bumper front	Stone chip	Slight	
4	Side panel left	Dent	Severe	
5	Bumper rear	Scratch	Slight	
6	Door FR	Scratch	Slight	
7	Mirror cap right	Stone chip	Slight
