REPORTNUMBER: 202312-24670

## Report

<b>Subject</b>	Report
<b>Inspection date/location</b>	27.12.2023   Dick Automobile e.K., Ernst-Abbe-Str. 2, DE-36179 Bebra
<b>Client</b>	Dick Automobile e.K., Otto-Hahn-Str. 4-6, DE-36179 Bebra
<b>Registration number</b>	MTK-MI 684
<b>Vehicle Identification Number</b>	VF1RFA00063629159

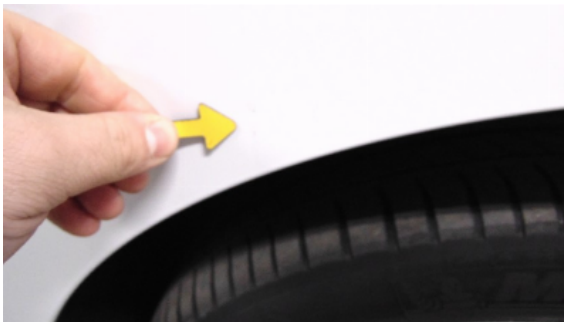
Image 1: siehe pos.1

Nr.	Component	Damage	Severity	Comment
1	Fender ri	Scratch	Slight	
2	Mirror cap right	Scratch	Slight	
3	Door FR	Scratch	Slight	
4	Door RR	Scratch	Slight	
5	Bumper rear	Scratch	Slight	
6	Tailgate panel	Scratch	Slight	
7	Door FL	Scratch	Slight
