REPORTNUMBER: 202404-26077

## Report

<b>Subject</b>	Report
<b>Inspection date/location</b>	25.04.2024   Dick Automobile e.K., Ernst-Abbe-Str. 2, DE-36179 Bebra
<b>Client</b>	Dick Automobile e.K., Otto-Hahn-Str. 4-6, DE-36179 Bebra
<b>Registration number</b>	LR-SK 484E
<b>Vehicle Identification Number</b>	WS5B16GAAJA800464

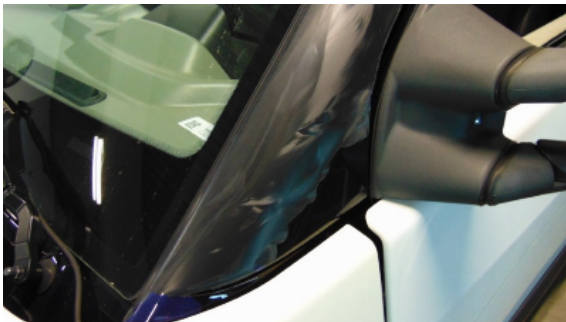
Image 1: Siehe Pos.1

Nr.	Component	Damage	Severity	Comment
1	A-pillar left		Severe	
2	Seat FL		Medium	
3	Roof		Severe	
4	Door RL	Scratch	Slight	
5	Door RR	Scratch	Slight
