Gerlach & Schröder GbR  
Nürnberger Str. 34  
DE-36199 Rotenburg a.d. Fulda/Lisp.

REPORTNUMBER: 202405-26205

## Report

<b>Subject</b>	Report
<b>Inspection date/location</b>	06.05.2024   Dick Automobile e.K., Ernst-Abbe-Str. 2, DE-36179 Bebra
<b>Client</b>	Dick Automobile e.K., Otto-Hahn-Str. 4-6, DE-36179 Bebra
<b>Registration number</b>	ME-LF 21
<b>Vehicle Identification Number</b>	WBA8H91050A855735

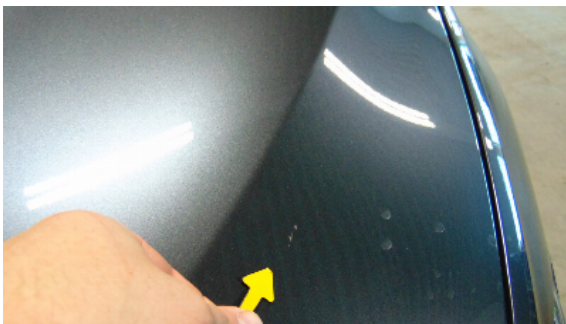
Image 1: siehe pos.1

Nr.	Component	Damage	Severity	Comment
1	Bonnet	Stone chip	Slight	
2	Bumper front	Stone chip	Slight	
3	Door FR	Scratch	Slight	
4	Bumper rear	Scratch	Slight	
5	Side panel left	Dent	Slight	
6	Door FL	Scratch	Slight
