REPORTNUMBER: 202409-27623

Report

Subject	Report
Client	Dick Automobile e.K., Otto-Hahn-Str. 4-6, DE-36179 Bebra
Inspection date/location	16.09.2024 Dick Automobile e.K., Ernst-Abbe-Str. 2, DE-36179 Bebra
Registration number	
Vehicle type	Estate Car
Manufacturer	BMW
Model / Sales description	218i Gran Tourer
Key numbers HSN/TSN	/
Vehicle identification number	WBA6V31010EB15026
Previous owners	
First registration	01.02.2018
Mileage	103.979 km
Colour / Colour Code	schwarz
Fuel Type	Petrol
Cubic Capacity / Power	/
Number of doors / seats	5 / 5
Transmission	Automatic transmission
Number of keys	1
Last maintenance	18.01.2024 / 90.315 km
Next vehicle inspection	
Service documentation	Available
Trailer coupling	No
Rain sensor	Available
Operating manual	Available
Repainting	Not Found
	Plastic parts could not be evaluated by means of paint thickness measurement.
Inspection Condition	non-dismantled, roadworthy, traffic safe

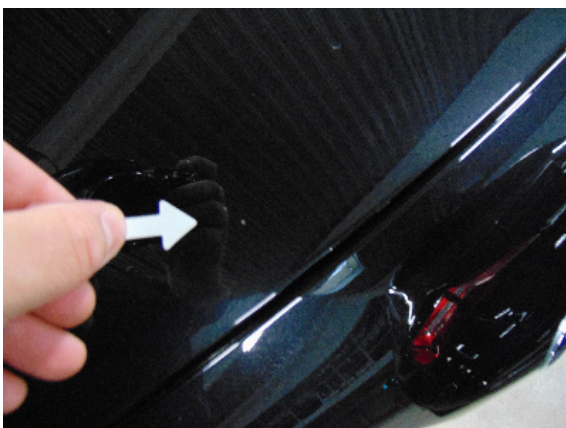
Image 1: siehe pos.1

Nr.	Component	Damage	Severity	Comment
1	Bonnet	Stone chip	Slight	
2	Bumper front	Stone chip	Slight	
3	Bumper rear	Scratch	Slight	
4	Side panel left	Scratch	Slight
