Gerlach & Schröder GbR
Nürnberger Str. 34
DE-36199 Rotenburg a.d. Fulda/Lisp.

REPORTNUMBER: 202405-26179

Report

Subject	Report
Inspection date/location	03.05.2024 Dick Automobile e.K., Ernst-Abbe-Str. 2, DE-36179 Bebra
Client	Dick Automobile e.K., Otto-Hahn-Str. 4-6, DE-36179 Bebra
Registration number	RO-DS 440
Vehicle Identification Number	6FPPXXMJ2PFC44660

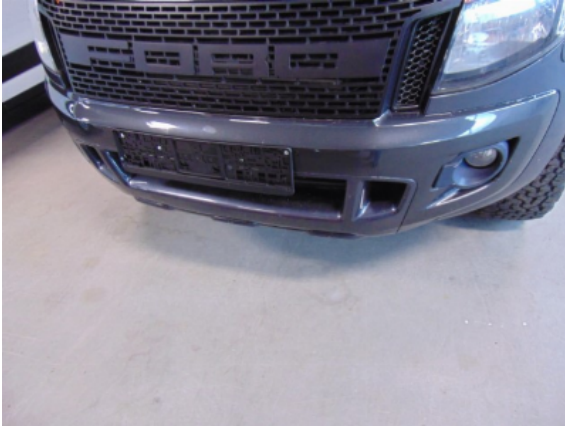
Image 1: Siehe Pos.1

Nr.	Component	Damage	Severity	Comment
1	Bumper front	Stone chip	Slight	
2	Bonnet		Medium	
3	Fender le		Slight	
4	Door FL		Slight	
5	Door panel FL		Slight	
6	Seat FL		Severe	
7			Medium	
8			Slight	
9	Door RL		Slight	
10	Door panel RL		Slight	
11		Paint chipping	Slight	
12	Side panel right		Slight

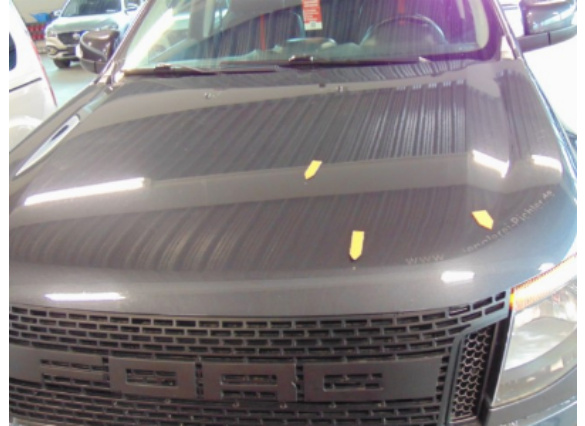
Image 2: Siehe Pos.2

- Bumper fr.;
- Engine bonnet; ~ 150µm
- Fender le; ~ 155µm
- Fender ri.; ~ 155µm

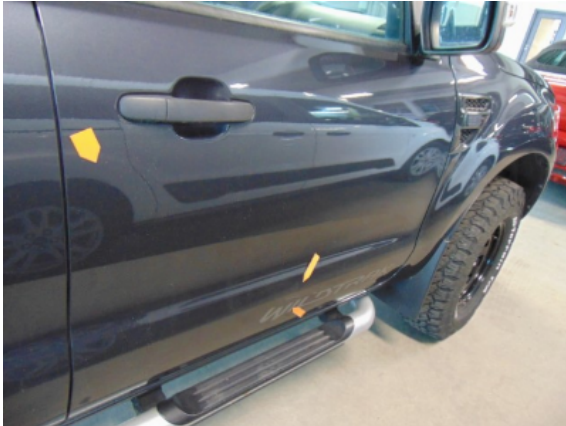
Image 13: Siehe Pos.13

13	Fender ri	Scratch	Slight
14	Door FR		Medium
15	Door RR		Medium
16	Side panel right	Scratch	Medium
17	Tailgate		Medium
