REPORTNUMBER: 202404-25917

## Report

<b>Subject</b>	Report
<b>Inspection date/location</b>	13.04.2024   Dick Automobile e.K., Ernst-Abbe-Str. 2, DE-36179 Bebra
<b>Client</b>	Dick Automobile e.K., Otto-Hahn-Str. 4-6, DE-36179 Bebra
<b>Registration number</b>	WÜ-XL 1072
<b>Vehicle Identification Number</b>	WF0DXXTTGDGR10625

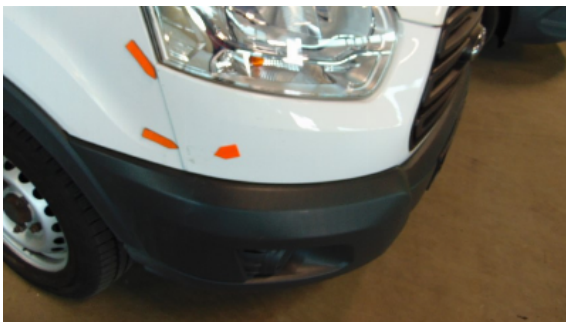
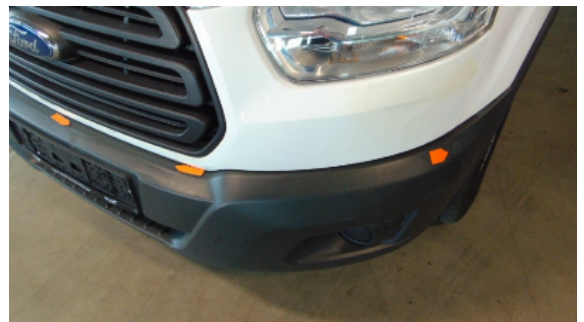
Nr.	Component	Damage	Severity	Comment
1	Bumper front		Medium	
2	Door FL		Slight	
3	Seat FL		Slight	
4			Slight	
5		Deformation	Medium	
6	Roof	Deformation	Slight	
7	Fender ri		Slight	
8	Door FR	Dent	Slight	
9		Deformation	Severe	
10			Severe

Image 1: Siehe Pos.1

Image 2: Siehe Pos.1

- Bumper fr.;

A sample-like paint thickness measurement showed an increased paint thickness, which is almost certainly due to a repaired damage.

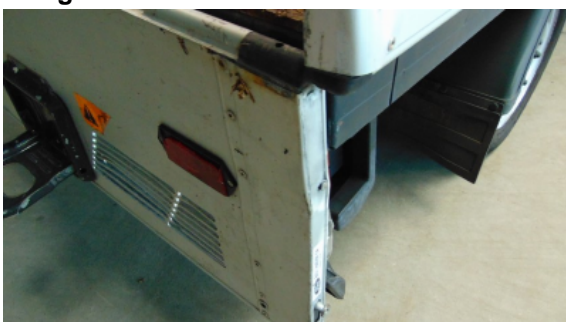
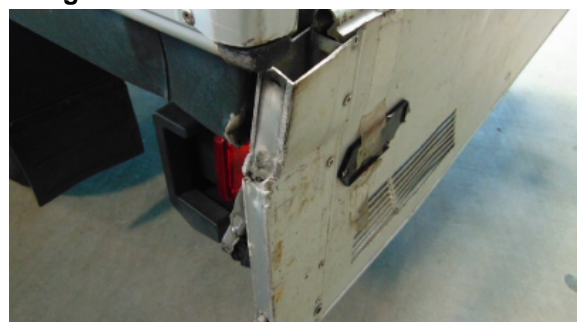
Image 11: Siehe Pos.10

Image 12: Siehe Pos.10

Image 13: Siehe Pos.10
