REPORTNUMBER: 202403-25641

## Report

<b>Subject</b>	Report
<b>Inspection date/location</b>	22.03.2024   Dick Automobile e.K., Ernst-Abbe-Str. 2, DE-36179 Bebra
<b>Client</b>	Dick Automobile e.K., Otto-Hahn-Str. 4-6, DE-36179 Bebra
<b>Registration number</b>	FB-NB 1312
<b>Vehicle Identification Number</b>	WBA3P11070K264072

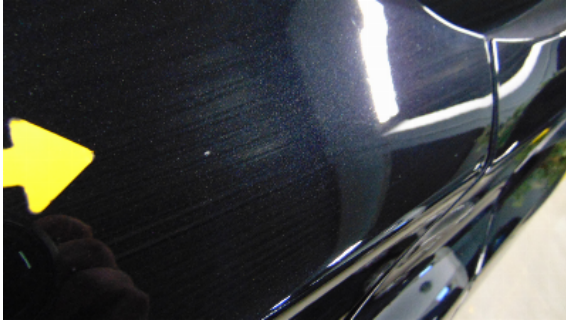
Image 1: siehe pos.1

Nr.	Component	Damage	Severity	Comment
1	Bonnet	Stone chip	Slight	
2	Bumper front	Stone chip	Slight	
3	Aluminium rim FR	Scratch	Medium	
4	Aluminium rim RR	Scratch	Medium	
5	Aluminium rim RL	Scratch	Medium	
6	Aluminium rim FL	Scratch	Medium	
7	Bumper rear	Scratch	Slight	
8	Side panel left	Scratch	Slight	
9	Door FL	Scratch	Slight
