REPORTNUMBER: 202404-25981

Report

Subject	Report
Inspection date/location	18.04.2024 Dick Automobile e.K., Ernst-Abbe-Str. 2, DE-36179 Bebra
Client	Dick Automobile e.K., Otto-Hahn-Str. 4-6, DE-36179 Bebra
Registration number	B-TM 92592
Vehicle Identification Number	U5YPG812AKL704122

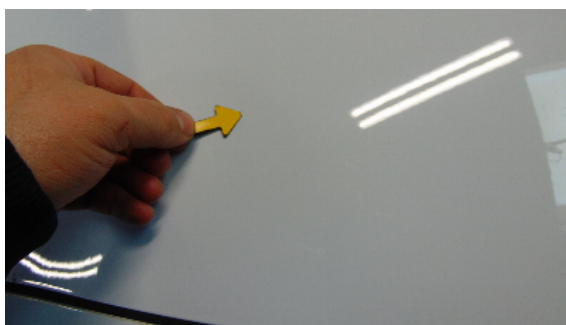
Image 1: siehe pos.1

Nr.	Component	Damage	Severity	Comment
1	Bonnet	Stone chip	Slight	
2	Bumper front	Stone chip	Slight	
3	Tailgate panel	Scratch	Slight	
4	Bumper rear	Scratch	Slight
