REPORTNUMBER: 202404-25541

Report

Subject	Report
Inspection date/location	14.03.2024 Dick Automobile e.K., Ernst-Abbe-Str. 2, DE-36179 Bebra
Client	Dick Automobile e.K., Otto-Hahn-Str. 4-6, DE-36179 Bebra
Registration number	PLÖ-WP 19
Vehicle Identification Number	WVWZZZAUZJW297602

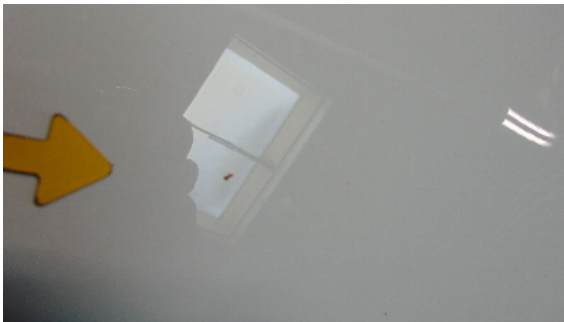
Image 1: siehe pos.1

Nr.	Component	Damage	Severity	Comment
1	Bonnet	Stone chip	Slight	
2	Bumper front	Stone chip	Slight	
3	Fender ri	Scratch	Slight	
4	Door FR	Scratch	Slight	
5	Bumper rear	Scratch	Slight	
6	Door FL	Scratch	Slight
