REPORTNUMBER: 202405-26245

## Report

<b>Subject</b>	Report
<b>Inspection date/location</b>	10.05.2024   Dick Automobile e.K., Ernst-Abbe-Str. 2, DE-36179 Bebra
<b>Client</b>	Dick Automobile e.K., Otto-Hahn-Str. 4-6, DE-36179 Bebra
<b>Registration number</b>	HEF-MM 434
<b>Vehicle Identification Number</b>	YF3YC3MFC12J44682

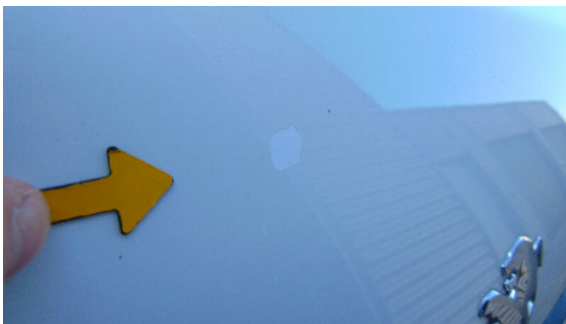
Image 1: siehe pos.1

Nr.	Component	Damage	Severity	Comment
1	Bonnet	Paint chipping	Slight	
2	Bumper front	Scratch	Slight	
3	Fender ri	Scratch	Slight	
4	Door FR	Scratch	Slight	
5	Door FR	Scratch	Slight	
6	Side panel right	Scratch	Slight	
7	Bumper rear	Scratch	Slight	
8	Tailgate	Scratch	Slight	
9	Side panel left	Scratch	Slight
