REPORTNUMBER: 202404-25900

## Report

<b>Subject</b>	Report
<b>Inspection date/location</b>	12.04.2024   Dick Automobile e.K., Ernst-Abbe-Str. 2, DE-36179 Bebra
<b>Client</b>	Dick Automobile e.K., Otto-Hahn-Str. 4-6, DE-36179 Bebra
<b>Registration number</b>	
<b>Vehicle Identification Number</b>	WVWZZZAUZGW513429

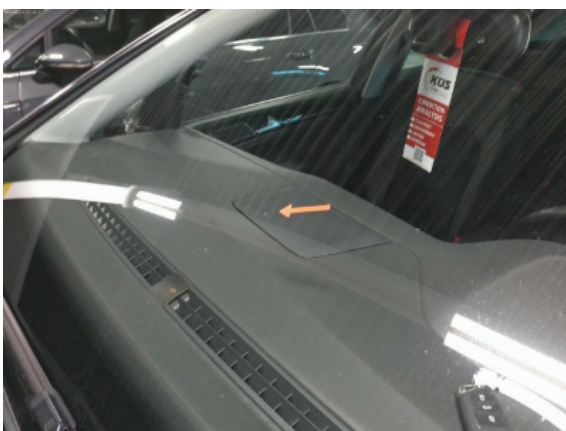
Image 1: Siehe Pos.1

Nr.	Component	Damage	Severity	Comment
1	Windshield	Stone chip	Medium	
2	Bonnet	Stone chip	Slight	
3	Bumper front	Stone chip	Slight	
4	Mirror cap left	Scratch	Slight	
5	Bumper rear	Scratch	Medium	
6	Tailgate	Scratch	Slight
