REPORTNUMBER: 202502-29258

## Report

<b>Subject</b>	Report
<b>Inspection date/location</b>	03.02.2025   Dick Automobile e.K., Ernst-Abbe-Str. 2, DE-36179 Bebra
<b>Client</b>	Dick Automobile e.K., Otto-Hahn-Str. 4-6, DE-36179 Bebra
<b>Registration number</b>	HH-GJ 5454
<b>Vehicle Identification Number</b>	WAUZZZFY1L2010881

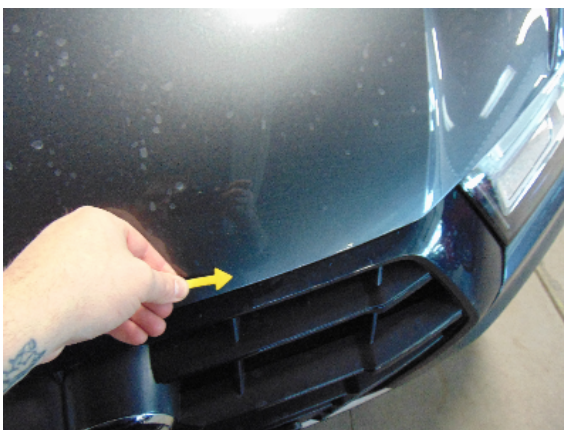
Image 1: siehe pos.1

Nr.	Component	Damage	Severity	Comment
1	Bonnet	Stone chip	Slight	
2	Bumper front	Stone chip	Slight	
3	Door FR	Scratch	Slight	
4	Door RR	Scratch	Slight	
5	Side panel right	Scratch	Slight	
6	Tailgate panel	Scratch	Slight	
7	Aluminium rim FL	Scratch	Slight
