REPORTNUMBER: 202501-29220

Report

Subject	Report
Inspection date/location	30.01.2025 Dick Automobile e.K., Ernst-Abbe-Str. 2, DE-36179 Bebra
Client	Dick Automobile e.K., Otto-Hahn-Str. 4-6, DE-36179 Bebra
Registration number	HD -EV 0619E
Vehicle Identification Number	WAUZZZFY8L2107043

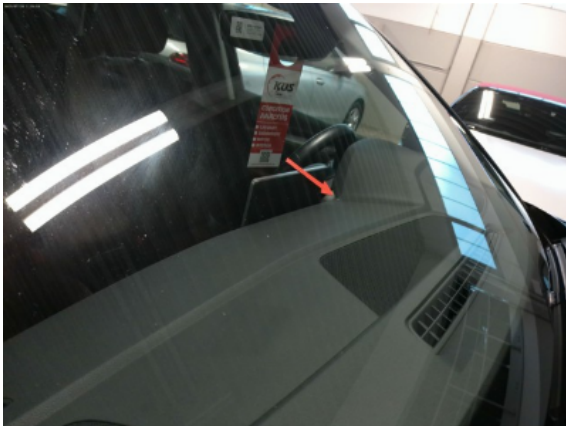
Image 1: Siehe Pos.1

Nr.	Component	Damage	Severity	Comment
1	Windshield	Stone chip	Slight	
2	Bonnet	Dent	Medium	
3	Bumper front	Stone chip	Slight	
4	Bonnet	Stone chip	Slight	
5	Mirror cap left	Stone chip	Slight	
6	Bumper rear	Scratch	Slight	
7	Mirror cap right	Stone chip	Slight
