REPORTNUMBER: 202410-27820

Report

Subject	Report
Client	Dick Automobile e.K., Otto-Hahn-Str. 4-6, DE-36179 Bebra
Inspection date/location	02.10.2024 Dick Automobile e.K., Ernst-Abbe-Str. 2, DE-36179 Bebra
Registration number	MB-DW 1002
Vehicle type	Estate Car
Manufacturer	Kia
Model / Sales description	Stonic 1.0 T-GDI 100 Vision Sports Utility
Key numbers HSN/TSN	8253 / AHR
Vehicle identification number	KNAD6811AL6447784
Previous owners	1
First registration	15.07.2020
Mileage	72.269 km
Colour / Colour Code	Blau
Fuel Type	Petrol
Cubic Capacity / Power	998 cm ³ / 74 kW
Number of doors / seats	5 / 5
Transmission	Manual gearbox
Number of keys	2
Last maintenance	27.05.2024 / 70.827 km
Next vehicle inspection	01.07.2025
Service documentation	Available
Trailer coupling	No
Rain sensor	Available
Operating manual	Available
Repainting	Found Plastic parts could not be evaluated by means of paint thickness measurement.
Inspection Condition	non-dismantled, roadworthy, traffic safe

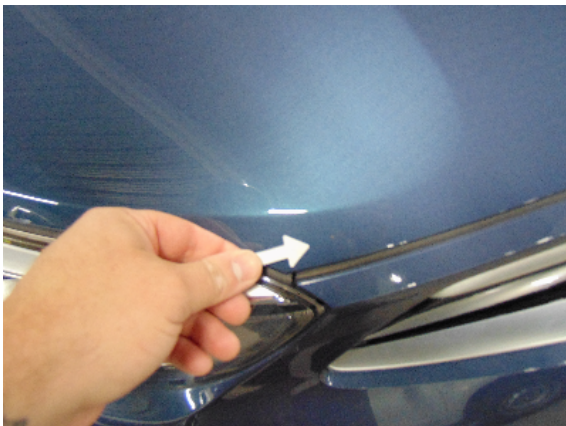
Image 1: siehe pos.1

Nr.	Component	Damage	Severity	Comment
1	Bonnet	Stone chip	Slight	
2	Bumper front	Stone chip	Slight	
3	Door entry FL	Scratch	Slight
