REPORTNUMBER: 202409-27658

Report

Subject	Report
Inspection date/location	18.09.2024 Dick Automobile e.K., Ernst-Abbe-Str. 2, DE-36179 Bebra
Client	Dick Automobile e.K., Otto-Hahn-Str. 4-6, DE-36179 Bebra
Registration number	A-SY 5124
Vehicle Identification Number	ZFA26300006R45463

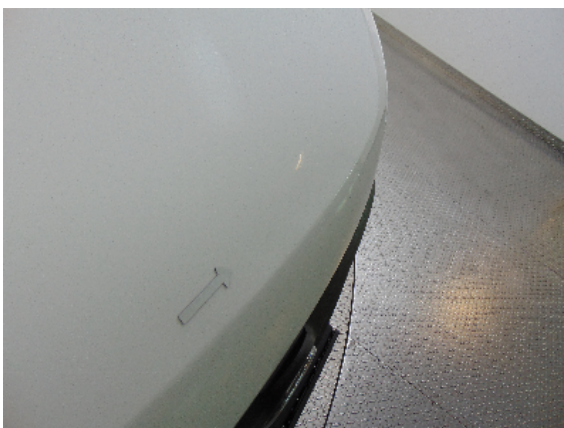
Image 1: siehe pos.1

Nr.	Component	Damage	Severity	Comment
1	Bonnet	Stone chip	Slight	
2	Bumper front	Stone chip	Slight	
3	Bumper rear	Scratch	Slight	
4	Fender le	Scratch	Slight
